Underwater Inspection of  
**I-40 over the  
Arkansas River**  
Sequoyah County, OK

July 19, 2020  
Structure No.  
6822-0000-X  
NBI No. 17051

**To:** Leslie Lewis, P.E.  
**From:** CONSOR Engineers, LLC  
**Date:** September 15, 2020  
**Subject:** Underwater Bridge Inspection  
NBI 17051, Structure 6822-0000-X, I-40 over the Arkansas River

**UNDERWATER INSPECTION REPORT  
OF  
Structure No. 6822-0000-X  
NBI No. 17051  
I-40  
Over the Arkansas River  
Sequoyah County**

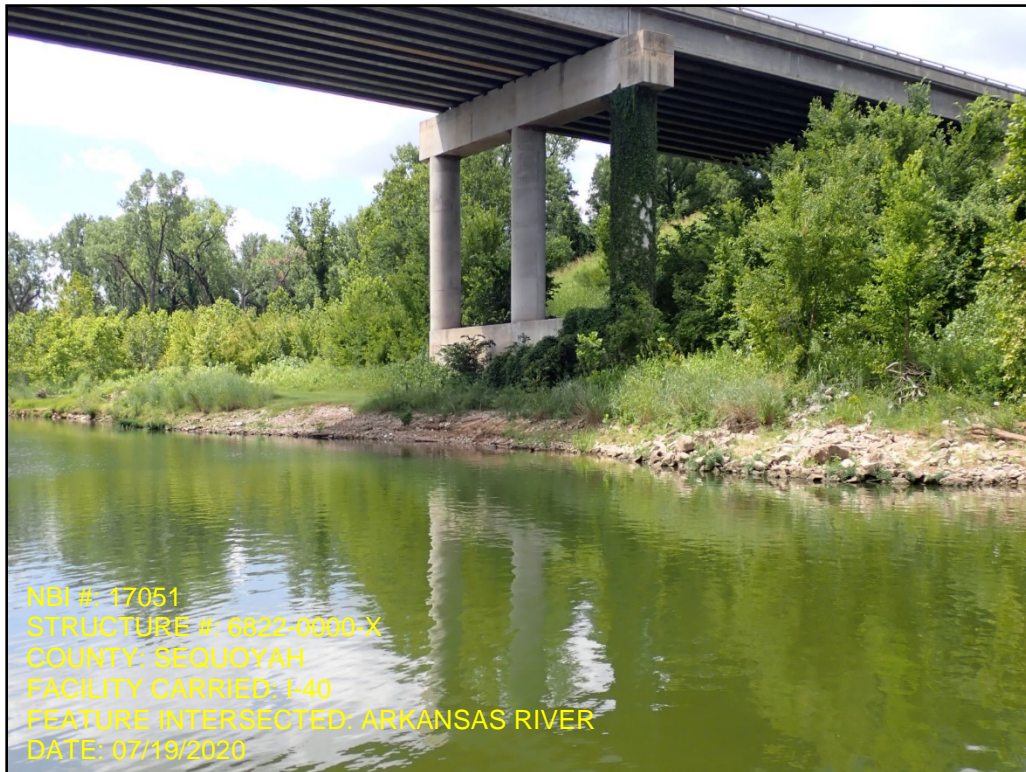
Photo 9 – West embankment

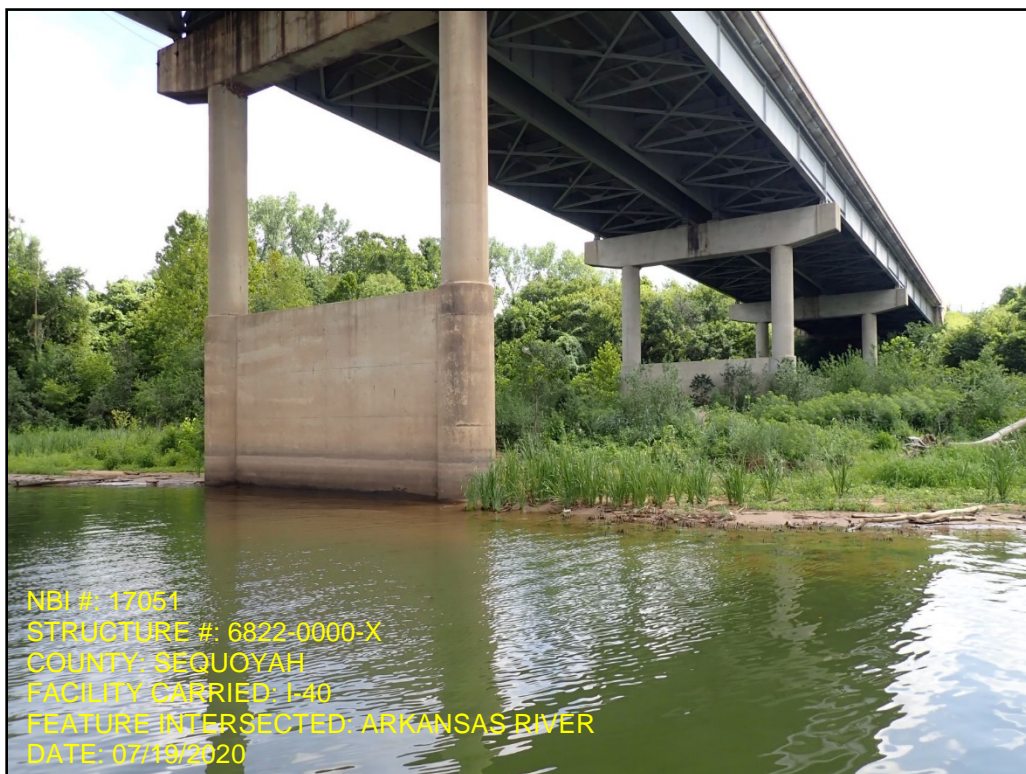
Photo 10 – East channel bank

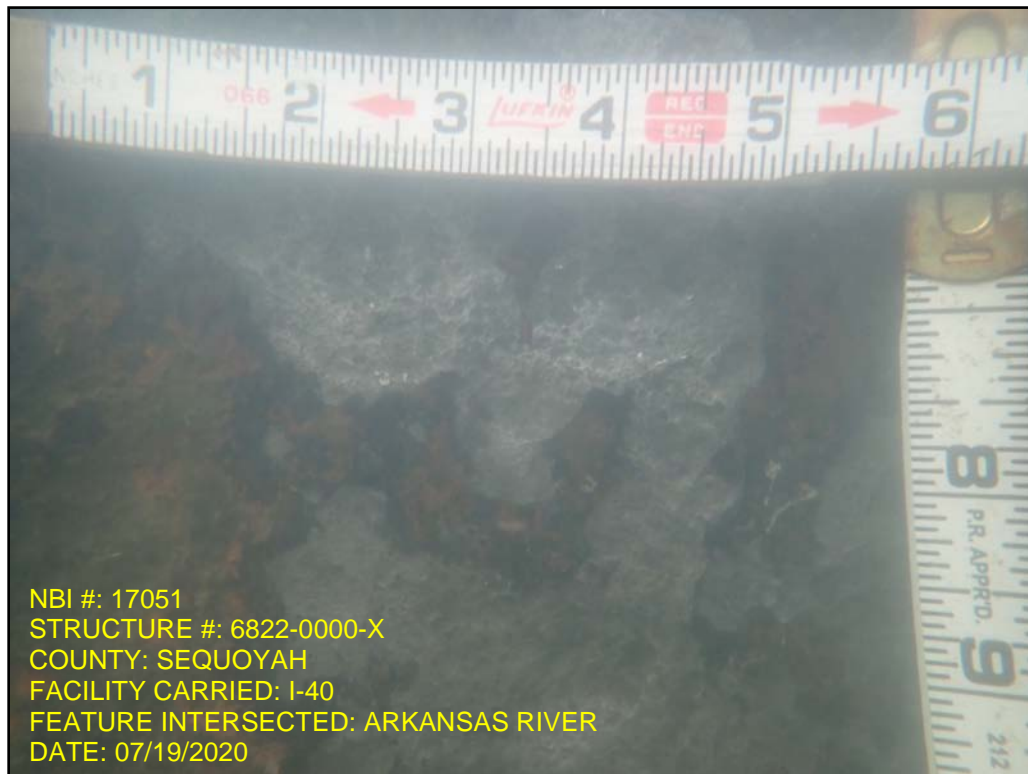
Piers 2 and 3: The steel encasements have minor pitting typically 1/16-in deep with random area up to 1/8-in deep. Refer to Photo 9. The steel encasements terminate 10-ft above the channel bottom.

Photo 11 – Pier 3, typical steel condition below waterline

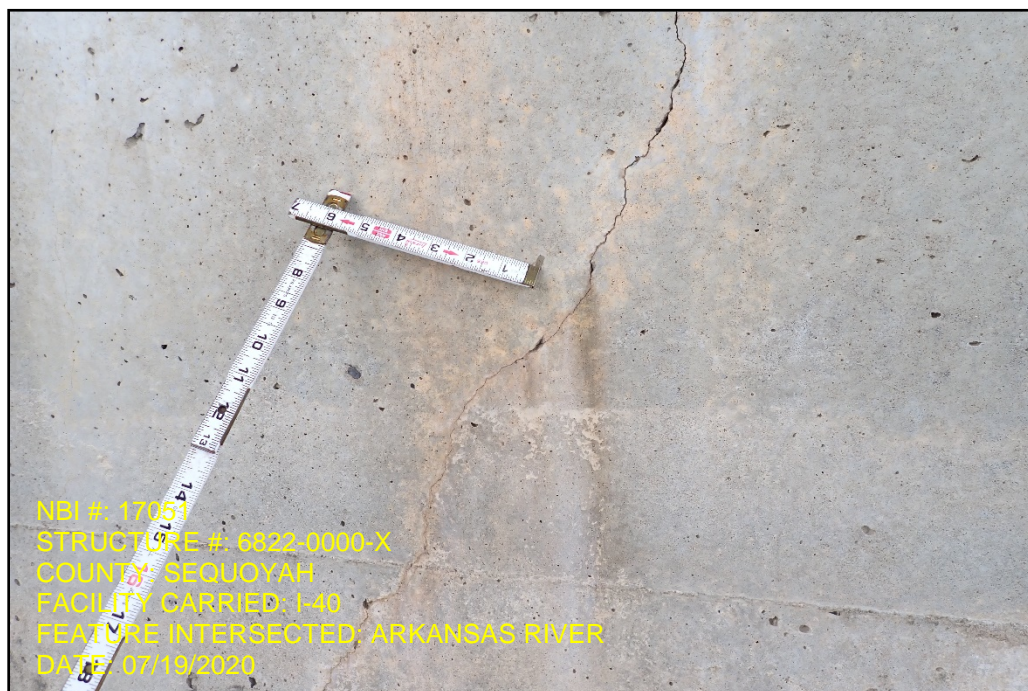
Pier 4: The encasement repair is in satisfactory condition. There are numerous vertical and horizontal cracks with efflorescence. Refer to Photo 10. There are isolated areas of rust staining. The cracks typically start at the waterline and extend to the top of the encasement. The encasement seal is exposed up to 10-ft high and is irregular with areas of voiding. The seal is in fair condition.

Photo 12 – Pier 4, typical cracking

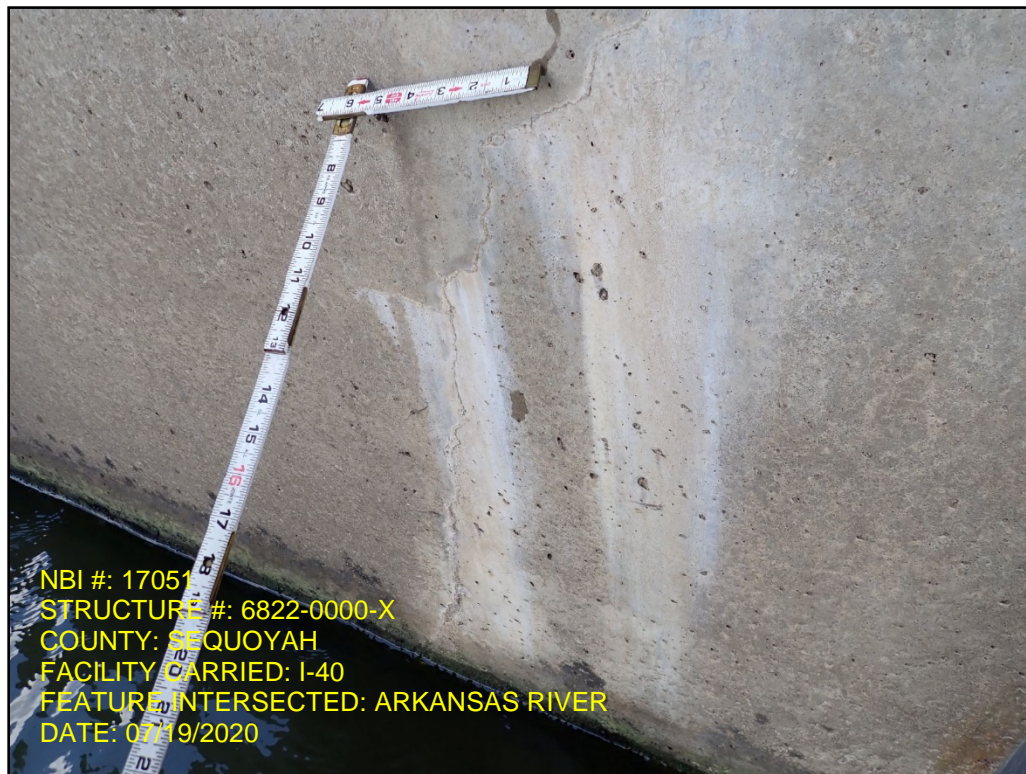
Pier 5: Hairline vertical cracks extend from the waterline up with some light efflorescence. The footing is exposed up to 4-in high over a 5-ft long area on the west face.

Photo 13 – Pier 5, typical crack with efflorescence

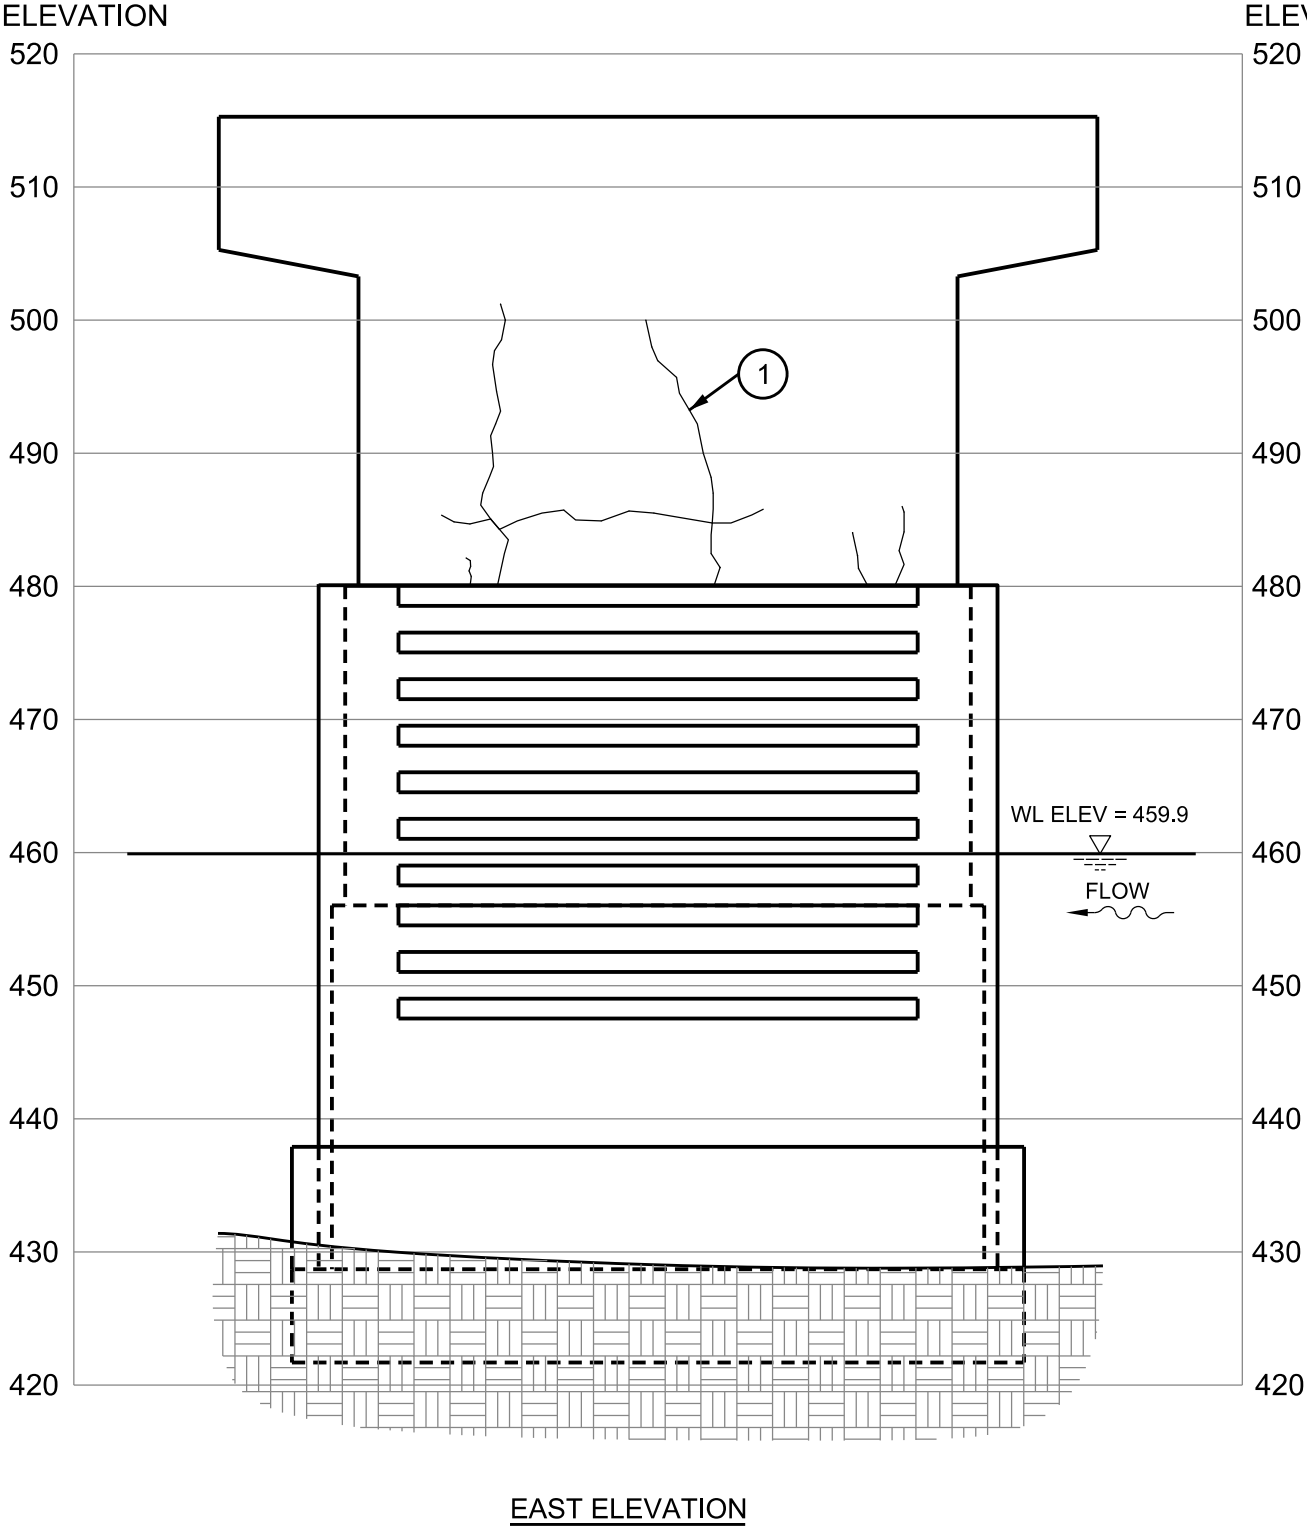
- INSPECTION NOTES:**
- GN THE ENCASEMENT REPAIR IS IN SATISFACTORY CONDITION.
  - GN THERE ARE ISOLATED AREAS OF RUST STAINING.
  - GN THE ENCASEMENT IS EXPOSED UP TO 10-FT HIGH AND IS IRREGULAR WITH AREAS OF VOIDING.
  - 1 THERE ARE NUMEROUS VERTICAL AND HORIZONTAL CRACKS WITH EFFLORESCENCE STARTING AT THE WATERLINE AND EXTEND TO THE TOP OF THE ENCASEMENTS.

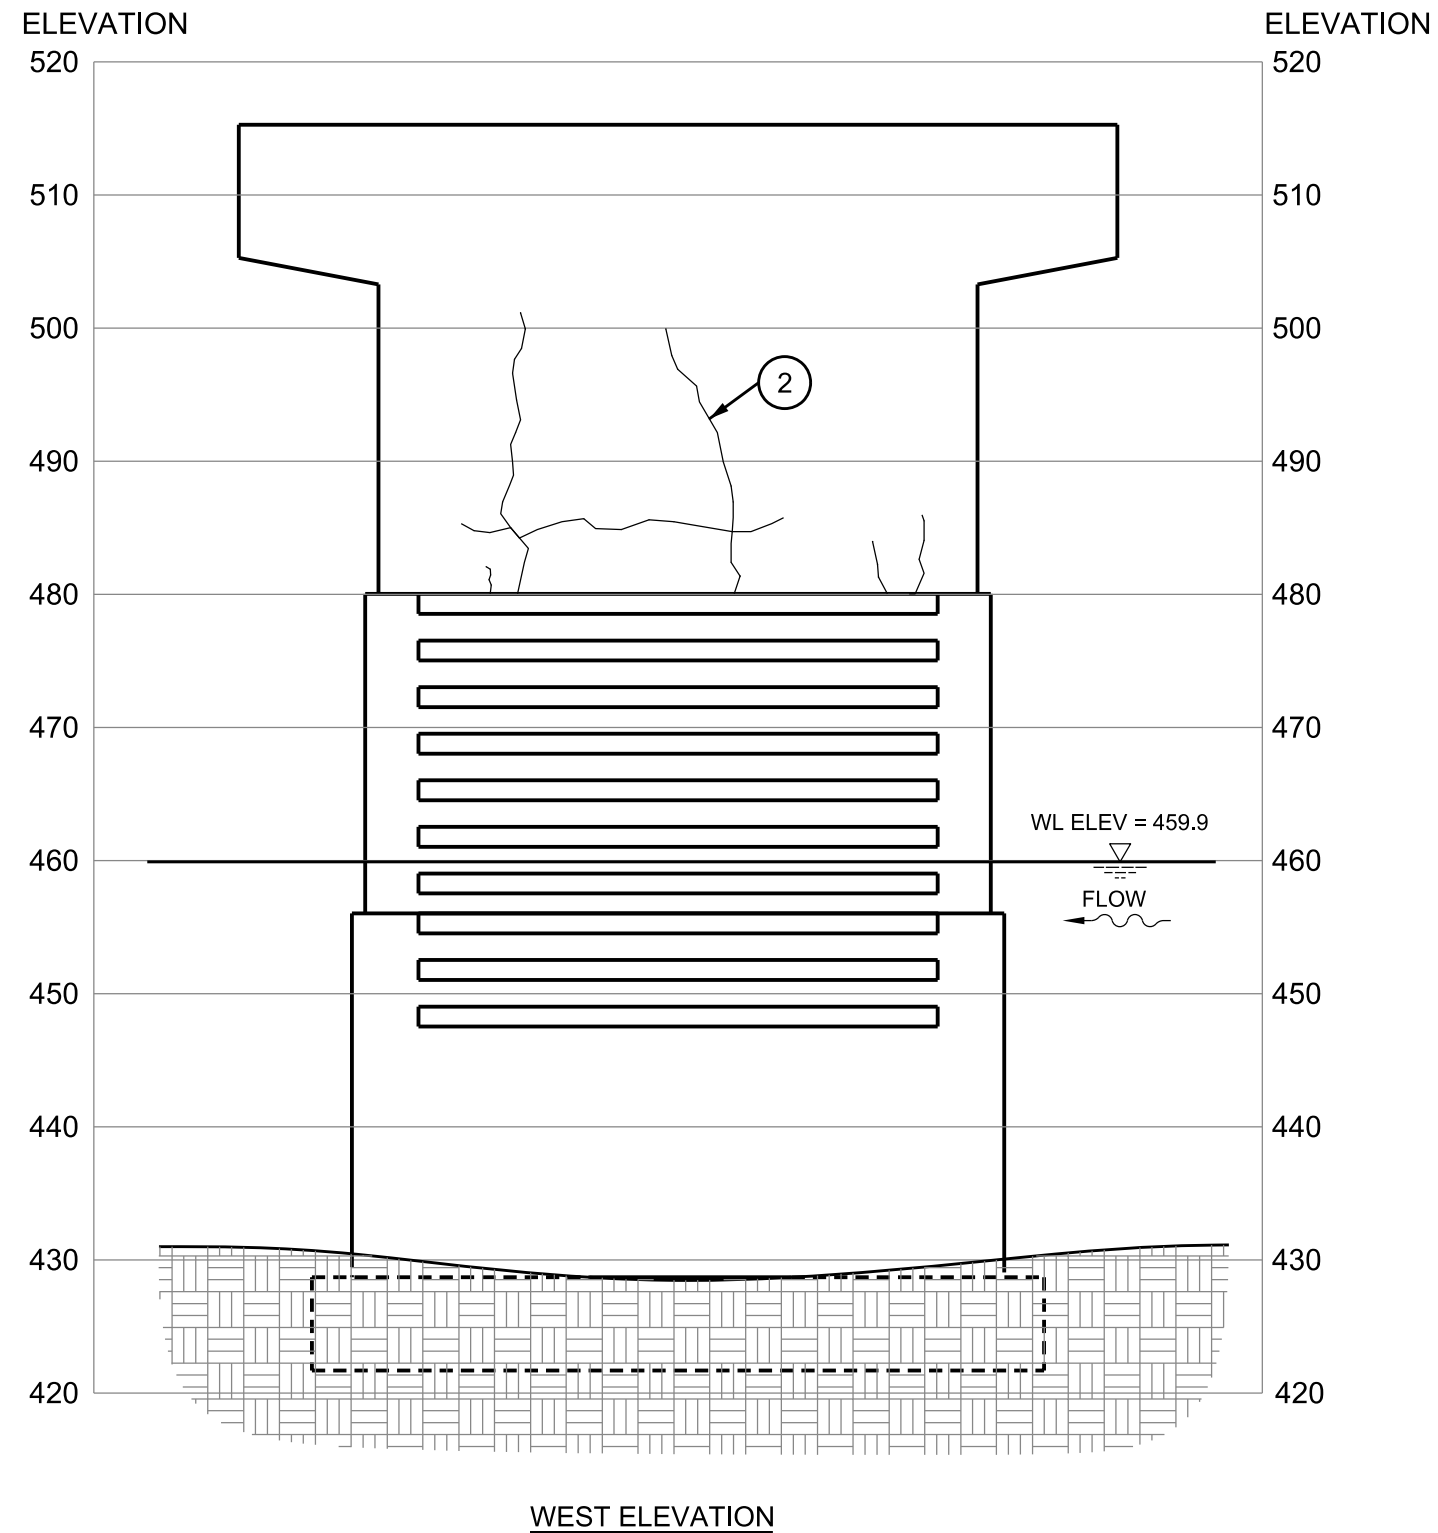
- GN THE PIER 5 FOOTING IS EXPOSED UP TO 4"H x 4'L ON THE WEST FACE.
- 2 PIER 5 HAS HAIRLINE VERTICAL CRACKS THAT START AT THE WATERLINE EXTENDING UP WITH SOME LIGHT EFFLORESCENCE.
