Oklahoma Dept. of Transportation - Bridge Inspection Report

NBI No.: 12788	Structure No.: 5156 1418 X	Local ID: -1	Suff. Rating: 67.00	ND
--------------------------	--------------------------------------	------------------------	-------------------------------	-----------

BRIDGE OWNER: DISTRICT 1
NBI NO.: 12788
STRUCTURE NO.: 5156 1418 X

COUNTY: MUSKOGEE
FACILITY CARRIED: U.S. 69
FACILITY INTERSECTED: COODY CREEK

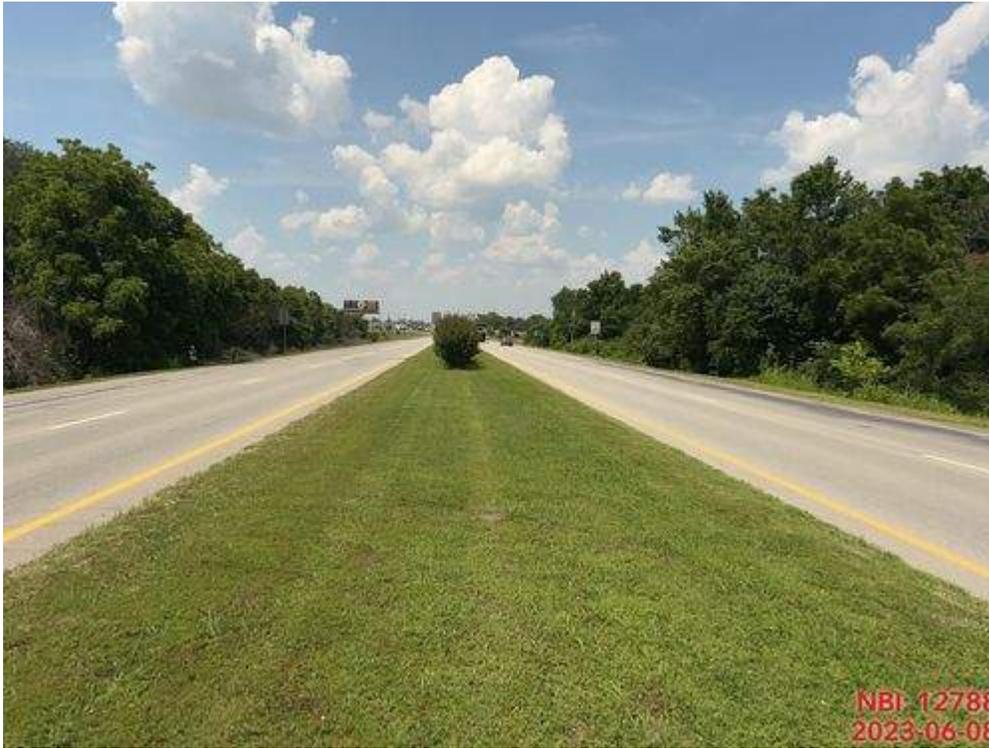
PHOTO 1: SOUTH APPROACH (LOOKING NORTH)

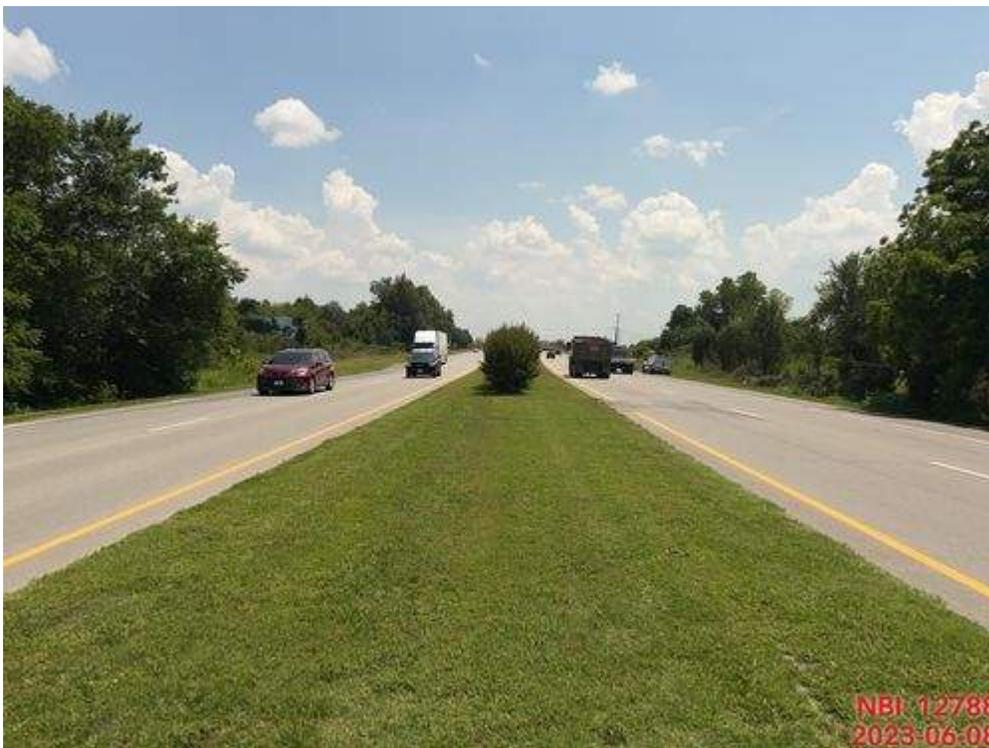
PHOTO 2: NORTH APPROACH (LOOKING SOUTH)

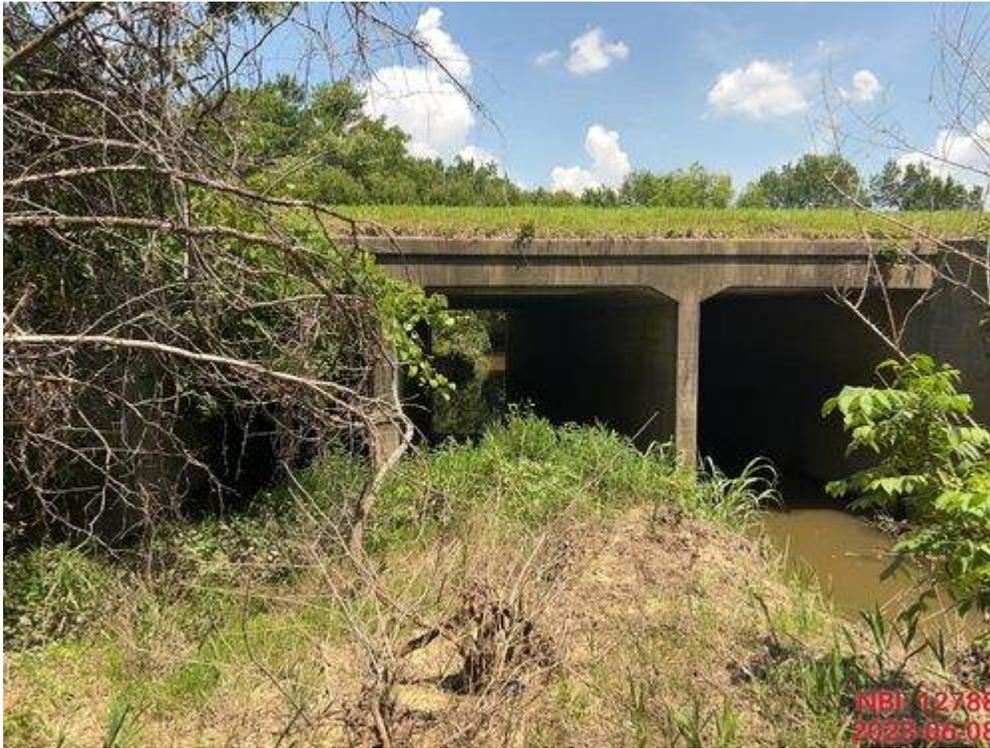
PHOTO 3: WEST PROFILE
(LOOKING EAST)

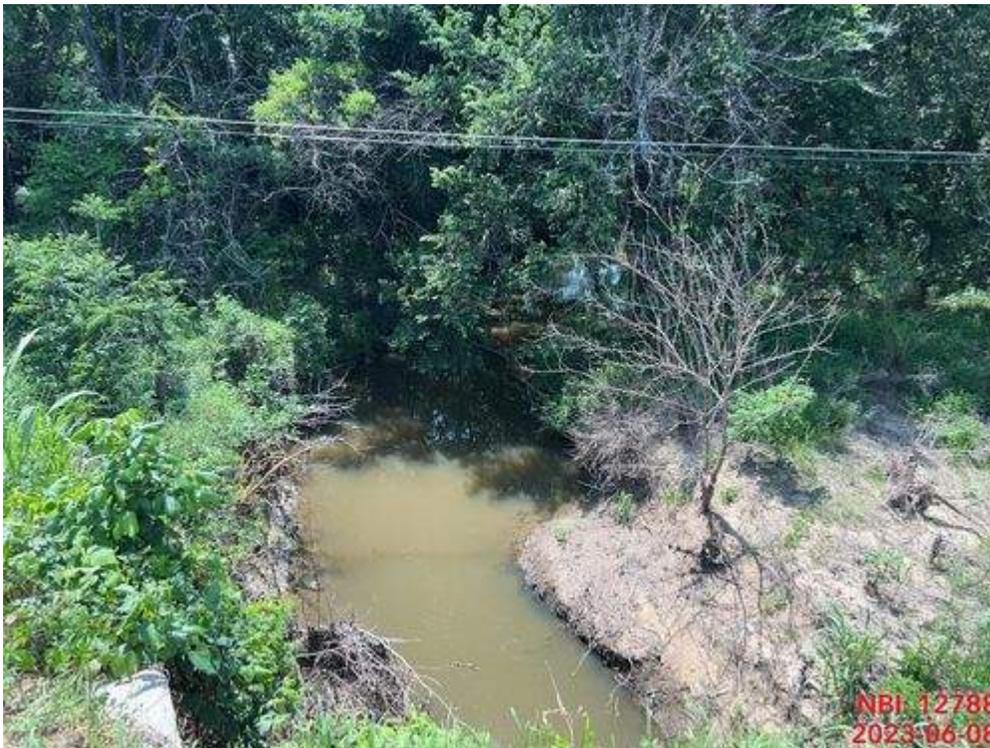
PHOTO 4: CHANNEL,
UPSTREAM
(LOOKING WEST)

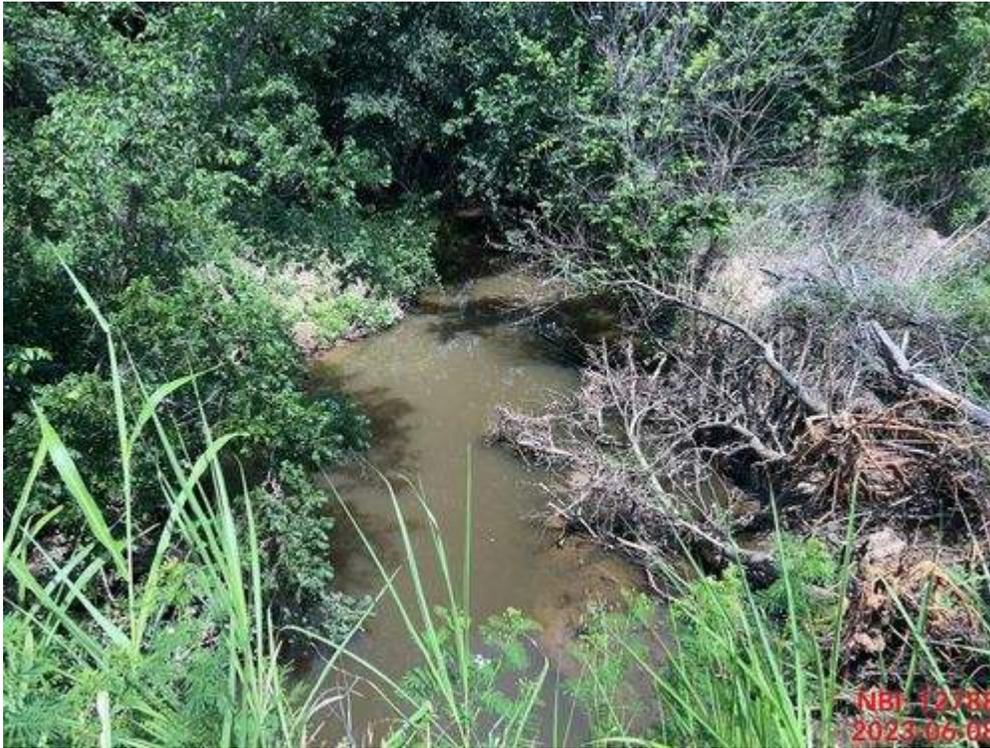
PHOTO 5: CHANNEL, DOWNSTREAM (LOOKING EAST)

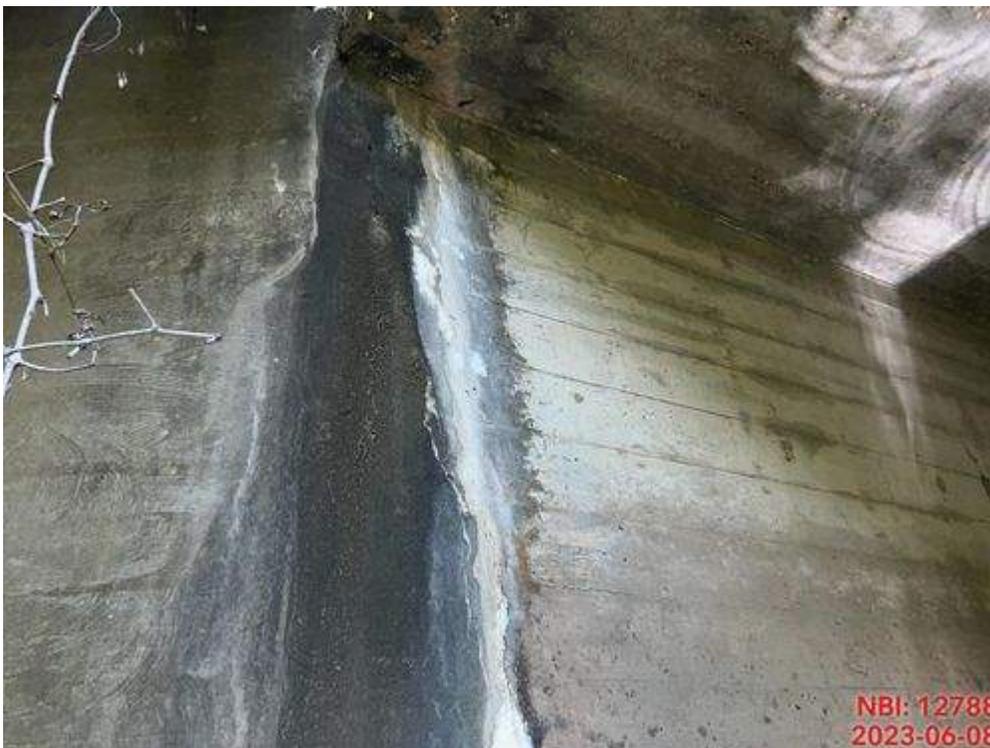
PHOTO 6: VERTICAL CRACK WITH EFFLORESCENCE AND HEAVY BUILDUP IN WALLS OF CELLS

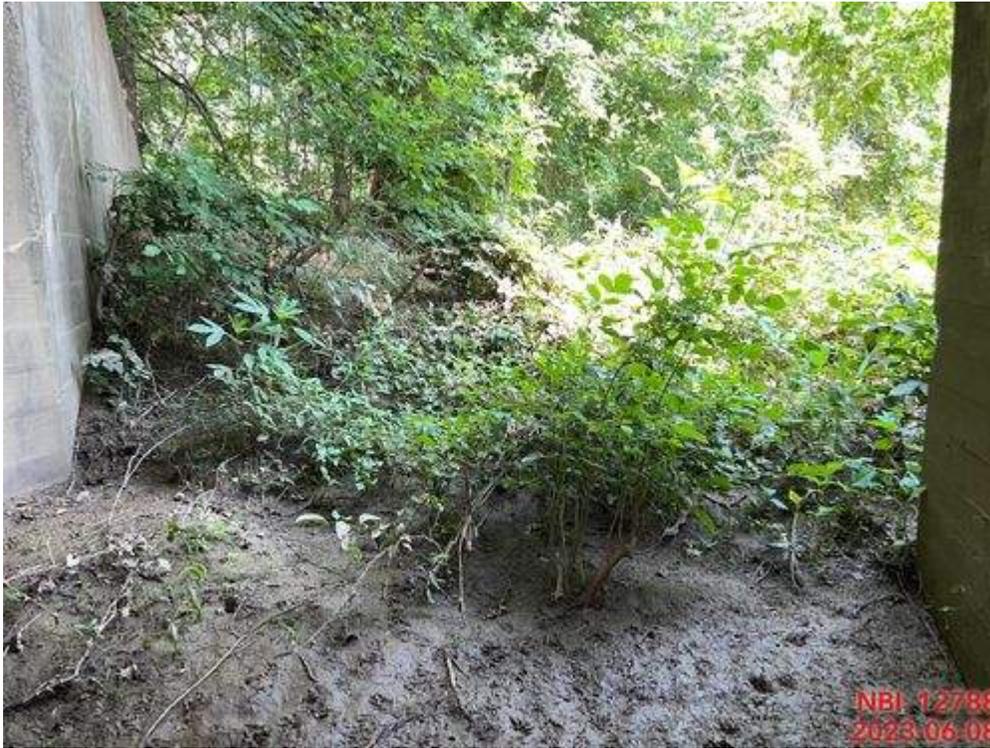
PHOTO 7: SEDIMENT AND VEGETATION OBSTRUCTING CELLS 2 & 3 UP TO 6FT UPSTREAM AND DOWNSTREAM
