Automatic Categorical Exclusion (ACE)

Date	May 4, 2023	Project No.	J3-0637(004)PM
County	Oklahoma	State Job Piece No.	30637(04)
NEPA Project Manager	F. Guerrero	Phone Number	405-982-0898
ODOT Field District	4	Bridge NBI No. <i>(County & State Projects)</i> & Location No. <i>(County Projects Only)</i>	NBI 18769 & 18770
Project Description from JPINFO	BRIDGE REHABILITATION I-44: OVER THE UPRR, 0.7 MILES NORTH OF I-40		
Purpose & Need	To correct ‘at-risk of becoming structurally deficient’ bridges.		
Description of the Proposed Action	<p>The proposed improvement consists of repairing the bridge decks, abutments, parapets, beams and superstructure along with reconstructing the bridge approach slabs, roadway and median. Soil will be removed and a soil nail wall will be installed to allow room for future Union Pacific Railroad (UPRR) track. A crash wall will also be constructed within UPRR right-of -way. All work will remain within existing right of way and will be coordinated with the UPRR, the roadway will remain open during construction by utilizing crossovers.</p>

BRIDGE "A" (EB) I-44 OVER UPRR & BLACK GOLD DRIVE		OKLAHOMA COUNTY		Design	JMB	10/20	
GENERAL PLAN AND ELEVATION CONSTR

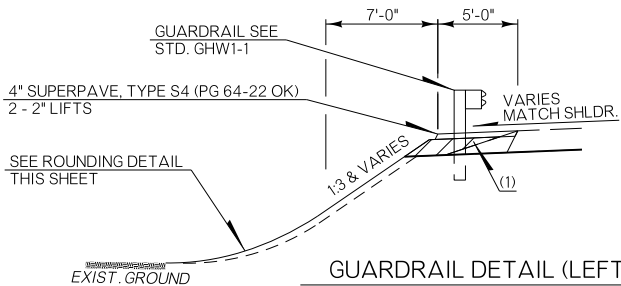
GUARDRAIL DETAIL (LEFT)		
ALIGNMENT	WIDTH	STATION EXTENTS
I-44 WB	0'-0" TO 5'-0"	STA. 373+78.29 TO STA. 374+47.65
I-44 WB	5'-0"	STA. 374+47.65 TO STA. 377+82.86
I-44 WB	5'-0"	STA. 381+23.14 TO STA. 393+55.87
I-44 WB	5'-0" TO 0'-0"	STA. 393+55.84 TO STA. 394+25.93
I-44 EB	0'-0" TO 5'-0"	STA. 374+34.46 TO STA. 375+04.25
I-44 EB	5'-0"	STA. 375+04.25 TO STA. 376+88.82

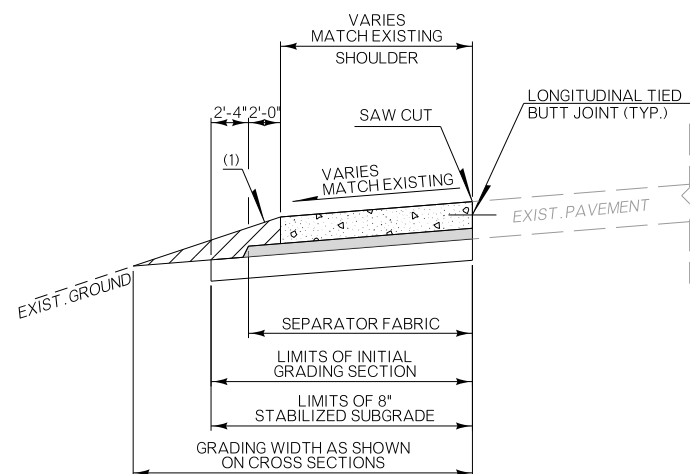
I-44 WESTBOUND SHOULDER RECONSTRUCTION TYPICAL NO. 1
STA. 362+60.74 TO STA. 378+18.62
STA. 381+07.31 TO STA. 388+52.79

PAVEMENT REQUIREMENT	
PAVT. STRUCTURE	SHOULDER RECONSTRUCTION
SURFACE COURSE	10" DOWEL JOINTED P.C. CONC. PVMT.
BASE COURSE	4" SUPERPAVE TYPE S3 (PG 64-22 OK)

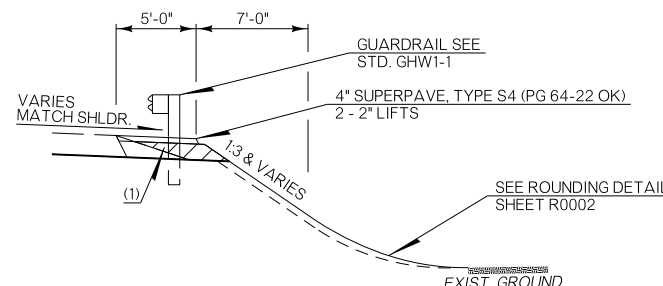
GUARDRAIL DETAIL (RIGHT)
SEE TABLE FOR STATION RANGES

GUARDRAIL DETAIL (RIGHT)		
ALIGNMENT	WIDTH	STATION EXTENTS
R 1-44 EB	0'-0" TO 5'-0"	STA. 373+53.75 TO STA. 374+24.85
R 1-44 EB	5'-0"	STA. 374+25.85 TO STA. 376+90.02
R 1-44 EB	5'-0"	STA. 380+44.31 TO STA. 390+38.96
R 1-44 FR	5'-0" TO 0'-0"	STA. 390+38.96 TO STA. 391+09.13

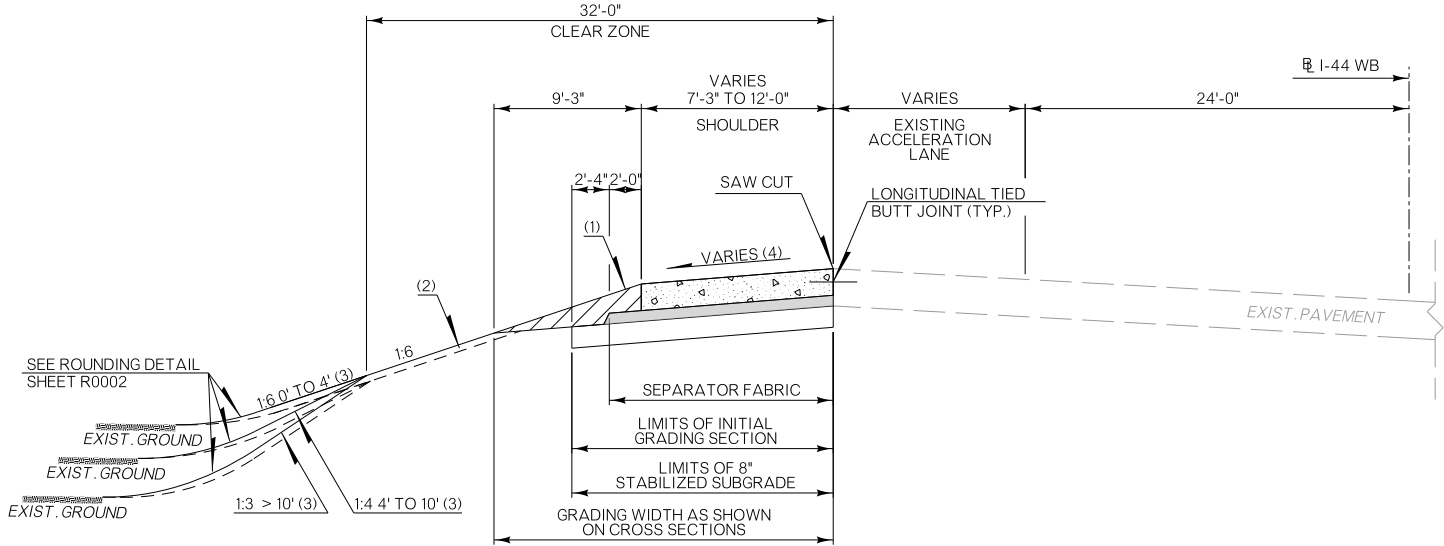
I-44 WESTBOUND WIDENING TYPICAL NO. 4
STA. 390+91.64 TO STA. 393+30.89

(1) BACKFILL NOTE:
TO BE BACKFILLED AND COMPACTED AS PART OF THE FINISHING OPERATIONS.
QUANTITY IS MEASURED IN TBSC TYPE E.

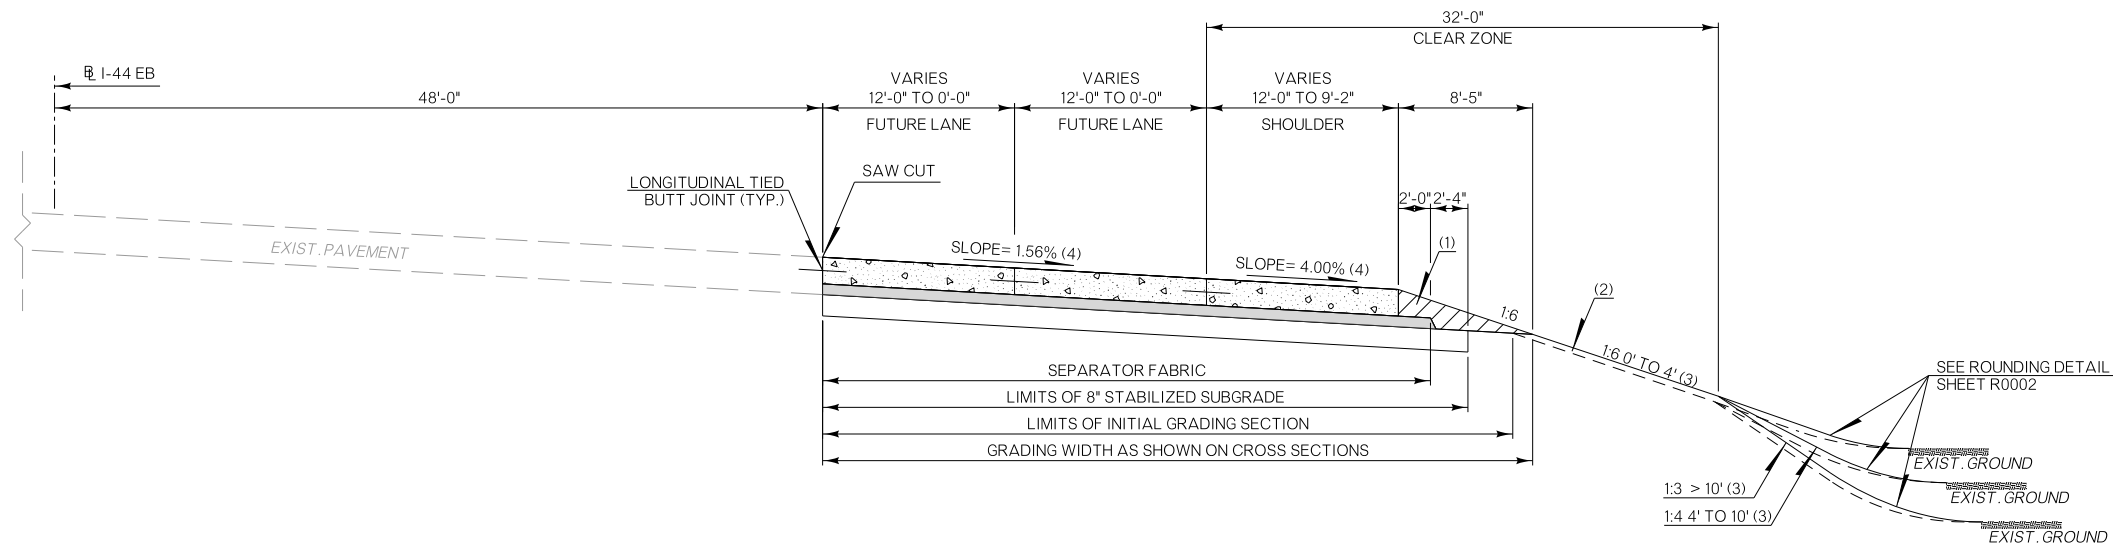
I-44 EASTBOUND WIDENING TYPICAL NO. 1

STA. 368+00.00 TO STA. 372+38.00
STA. 386+58.00 TO STA. 389+07.20

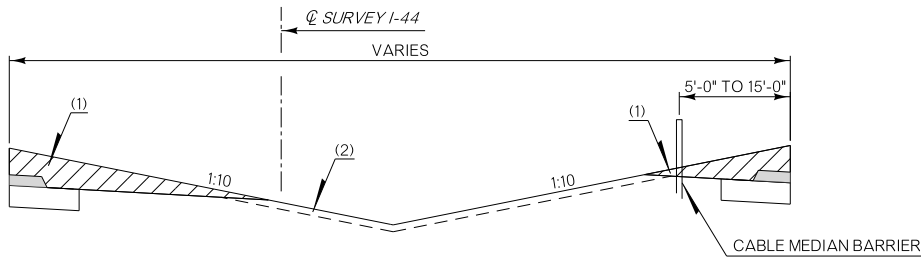
MEDIAN GRADING TYPICAL NO. 1
CL SURVEY I-44 STA. 372+54.00 TO STA. 375+50.00

PAVEMENT REQUIREMENT	
PAVT. STRUCTURE	PAVED MEDIAN
SURFACE COURSE	10" DOWEL JOINTED P.C. CONC. PVMT.
BASE COURSE	4" SUPERPAVE TYPE S3 (PG 64-22 OK)

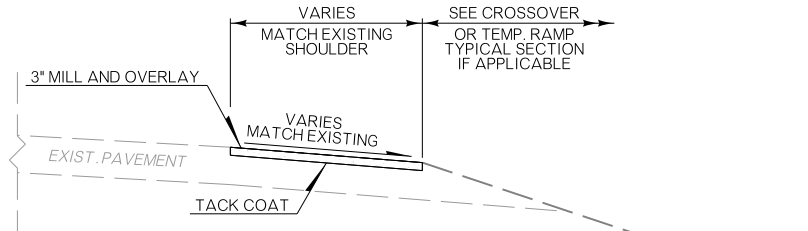
SHOULDER REHABILITATION TYPICAL NO. 1

- 1-44 WB STA. 362+60.74 TO STA. 378+18.62, OUTSIDE SHLDR.
1-44 WB STA. 381+07.31 TO STA. 388+52.79, OUTSIDE SHLDR.
1-44 WB STA. 395+41.18 TO STA. 396+86.00, OUTSIDE SHLDR.
1-44 WB STA. 362+60.74 TO STA. 377+97.91, INSIDE SHLDR.
1-44 WB STA. 380+85.00 TO STA. 390+84.32, INSIDE SHLDR.
1-44 EB STA. 364+82.35 TO STA. 377+37.97, INSIDE SHLDR.
1-44 EB STA. 380+30.40 TO STA. 390+53.00, INSIDE SHLDR.

PAVEMENT REQUIREMENT	
PAVT. STRUCTURE	SHOULDER
SURFACE COURSE	3" SUPERPAVE TYPE S4 (PG 64-22 OK)

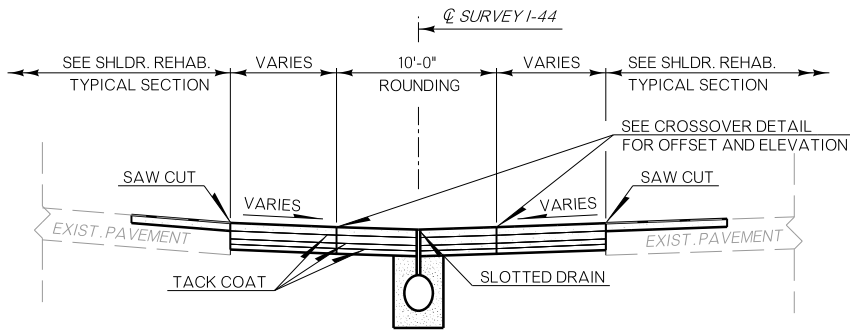
NORTH CROSSOVER TYPICAL NO. 1

1-44 STA. 385+11.22 TO STA. 389+19.06

PAVEMENT REQUIREMENT	
PAVT. STRUCTURE	CROSSOVER
SURFACE COURSE	3" SUPERPAVE TYPE S4 (PG 64-22 OK)
BASE COURSE	3" SUPERPAVE TYPE S3 (PG 64-22 OK)
	2" SUPERPAVE TYPE S3 (PG 64-22 OK)
	2" SUPERPAVE TYPE S3 (PG 64-22 OK)

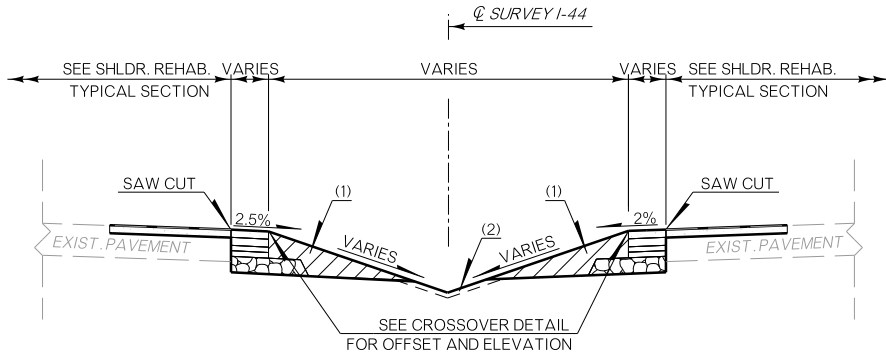
SOUTH CROSSOVER TYPICAL NO. 1

1-44 STA. 365+21.30 TO STA. 367+75.00
1-44 STA. 369+66.00 TO STA. 372+35.48

CROSSOVER INTERIOR GRADING SLOPES	
SLOPE	STATION EXTENTS
1:10	BEGIN TO STA. 367+75.00
1:6	STA. 369+66.00 TO STA. 370+45.00
1:6 TO 1:10	STA. 370+45.00 TO STA. 370+95.00
1:10	STA. 370+95.00 TO END

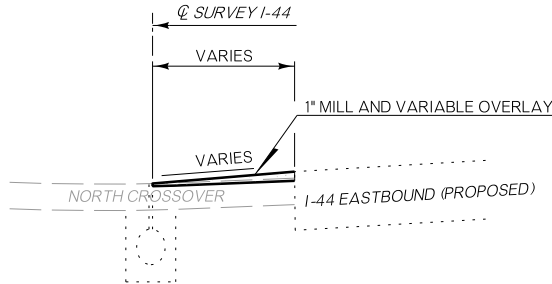
NORTH CROSSOVER TYPICAL NO. 2
(PHASE 3B MODIFICATION)

1-44 EB STA. 384+88.45 TO STA. 386+58.00

PAVEMENT REQUIREMENT	
PAVT. STRUCTURE	OVERLAY
SURFACE COURSE	3" SUPERPAVE TYPE S3 (PG 64-22 OK)

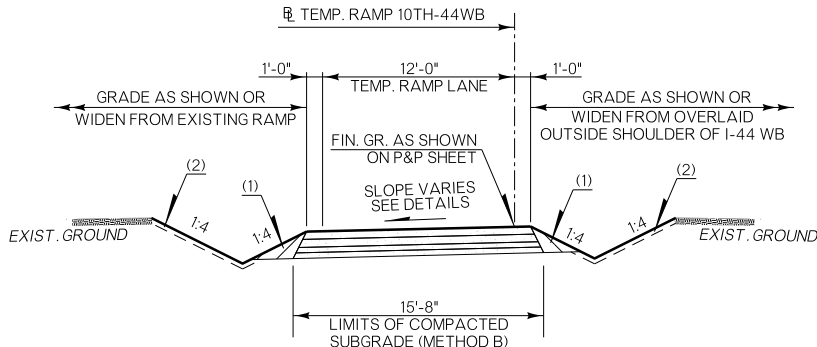
TYPICAL NO. 1
TEMPORARY RAMP 10TH-44WB

TEMP. RAMP 10TH-44WB STA. 396+17.76 TO STA. 399+29.59

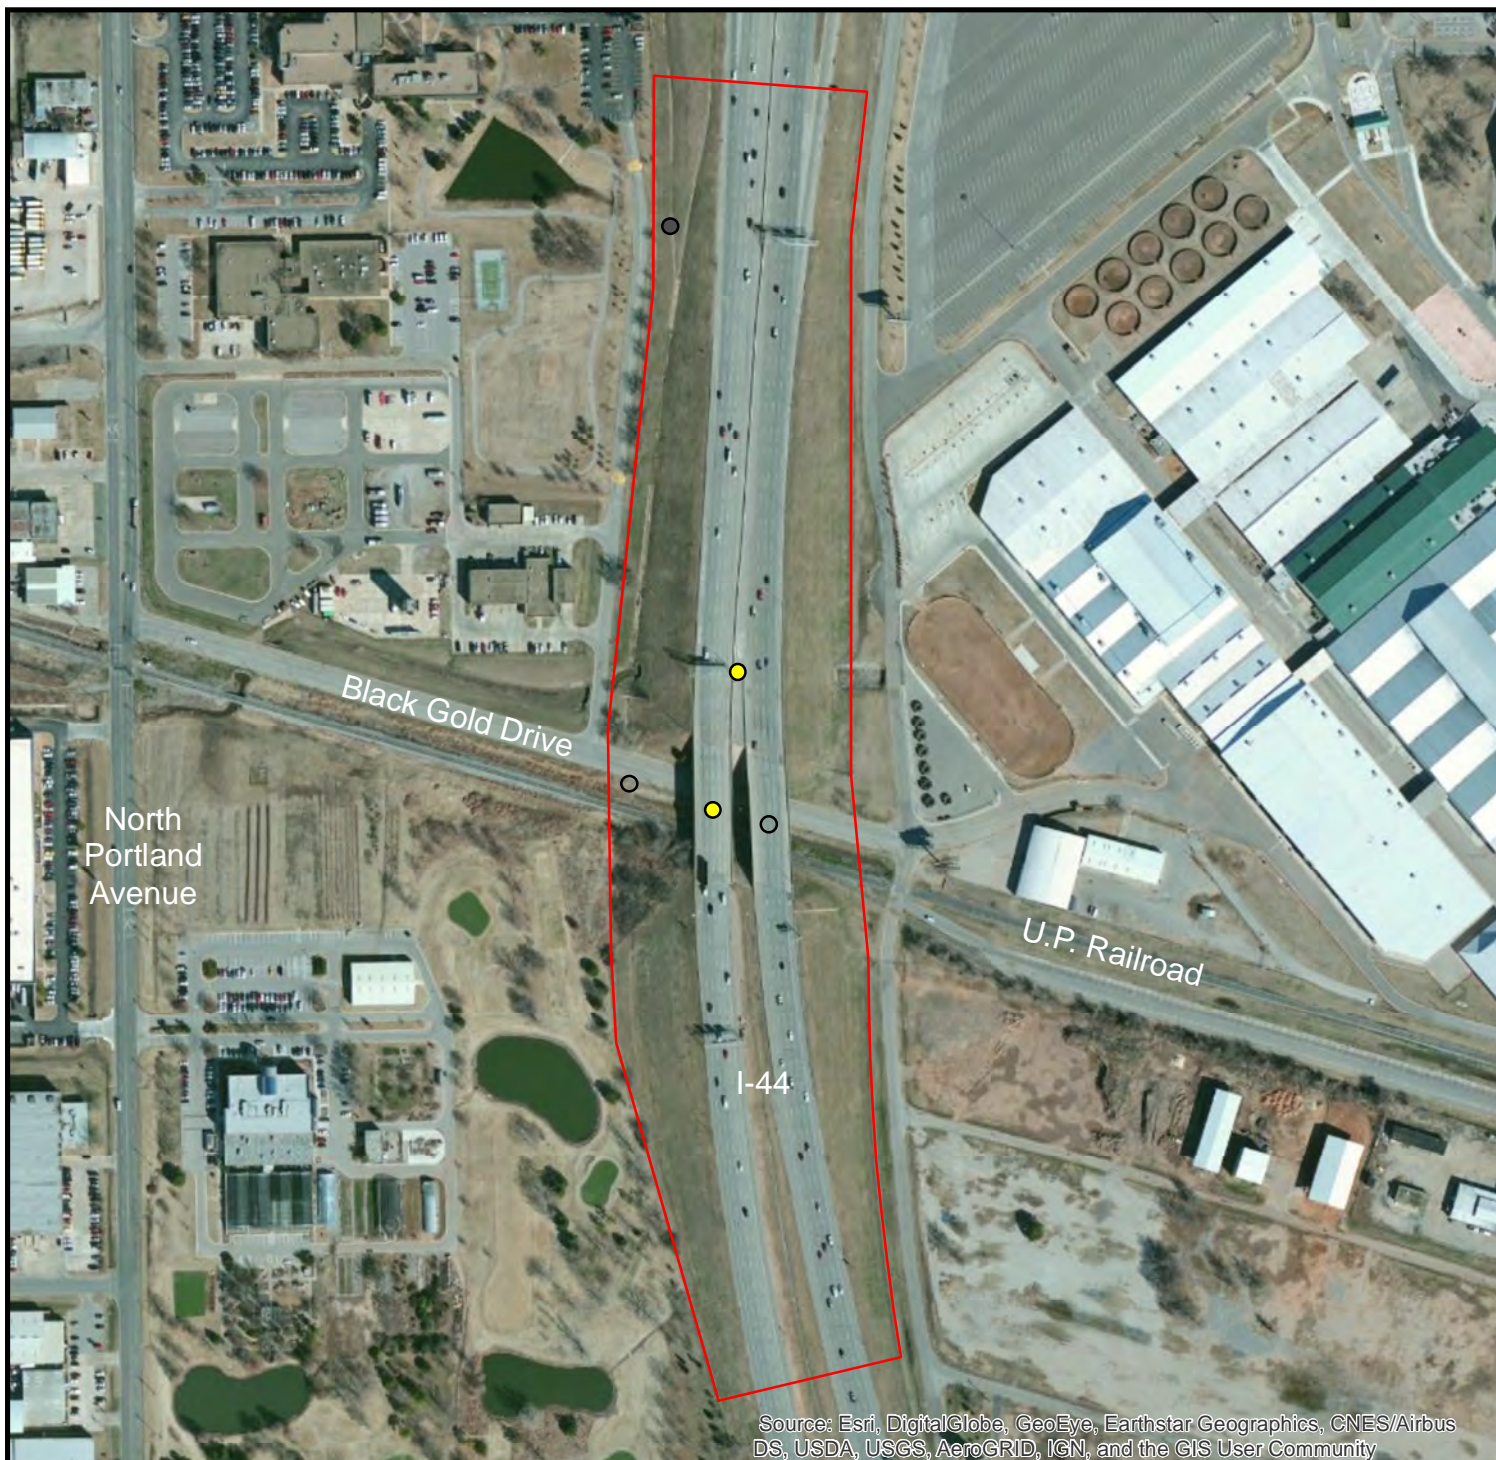
Figure 4. Swallow nest locations

- Study Area
- Barn and/or Cliff Swallow nest location
- Suitable swallow nest site without swallow nests
- Structure not suitable for swallow nests

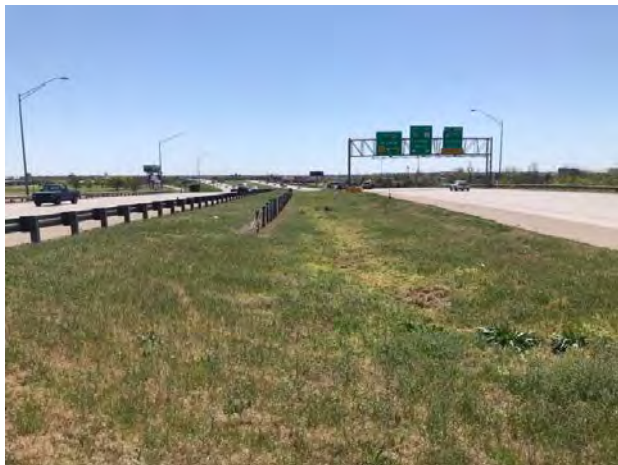
Photo Site 1 (PS 1): Existing R/W, looking south from the I-44 median at the top of the south slope wall.

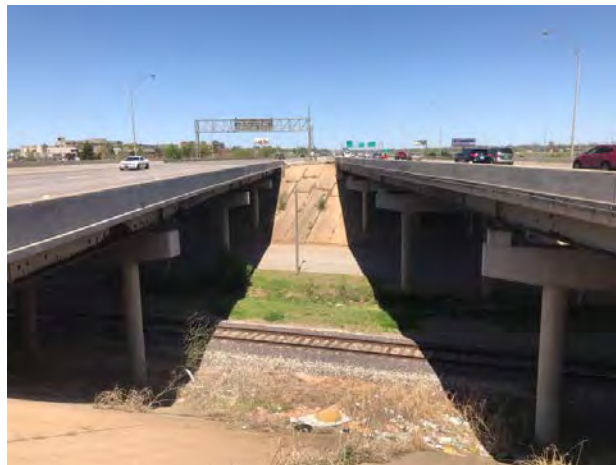
PS 1: Existing R/W, U.P. Railroad and Black Gold Drive, looking north from the I-44 median at the top of the south slope wall.

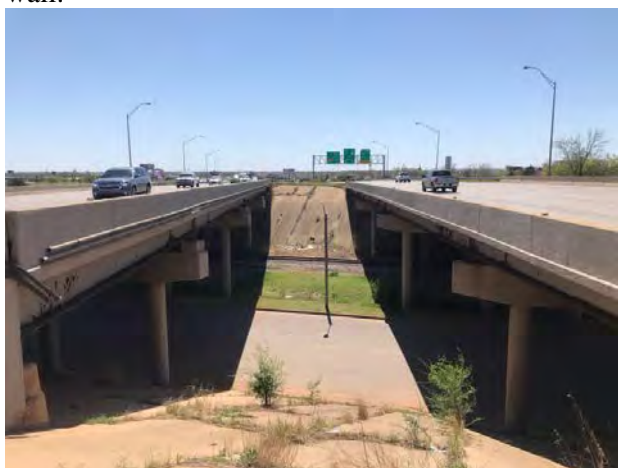
PS 2: Existing R/W, Black Gold Drive and U.P. Railroad, looking south from the I-44 median at the top of the north slope wall.

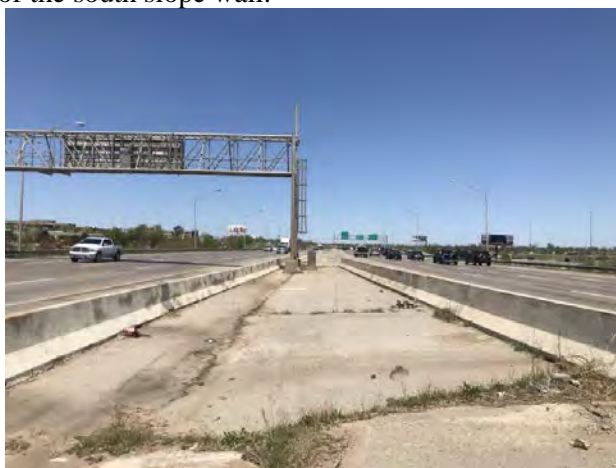
PS 2: Existing R/W, looking north from the I-44 median at the top of the north slope wall.

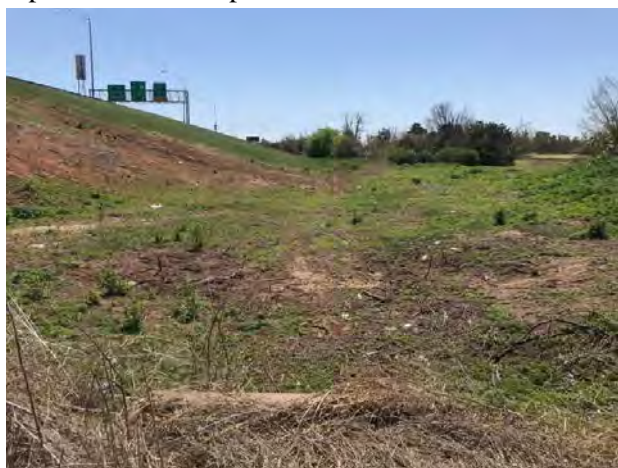
PS 3: Ephemeral drainage swale, looking south from the south side of the U.P. RR; vegetation has been recently (after January 2019) cleared from this area.

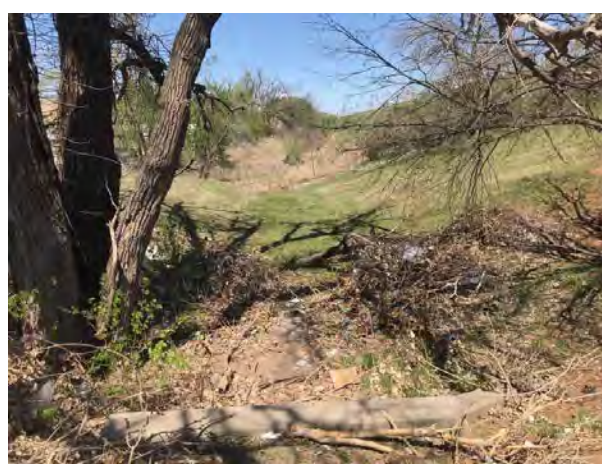
PS 4: Ephemeral drainage swale, looking north from the north side of Black Gold Drive.

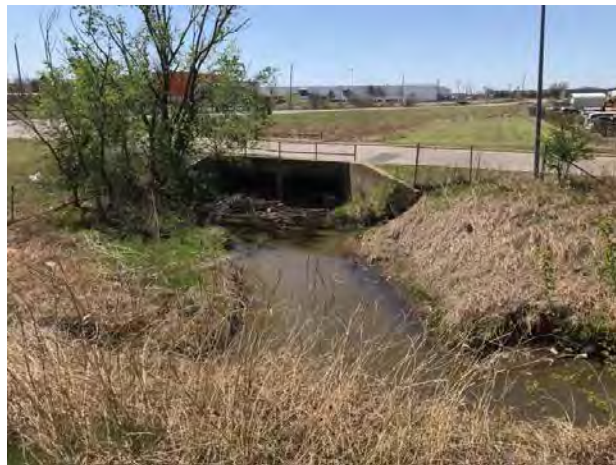
PS 6: Ephemeral stream, looking SW from the west end of the RCB that carries the feature under I-44.

Field Site 1 is an unmapped ephemeral drainage feature (see images from Photo Sites 5, 6, 7 and 8). An estimated 462.3 linear feet (0.247 acre) of Field Site 1 occur within the study area. This feature originates in developed uplands a short distance east of I-44, crosses under the highway via a twin RCB culvert, and drains west through an excavated and maintained drainage swale. Standing water was observed in the stream bed on the survey date. Most of that reach of this feature within the study area is confined to a twin (10'x5') RCB. Otherwise, the shaped and maintained banks are vegetated with those grass and forb species common to the right-of-way, as well as a few scattered saplings of white mulberry (*Morus alba*). Although this stream exhibits an evident OHWM, it is not mapped on the Oklahoma City (3509745) 7.5 minute topographic quad map and

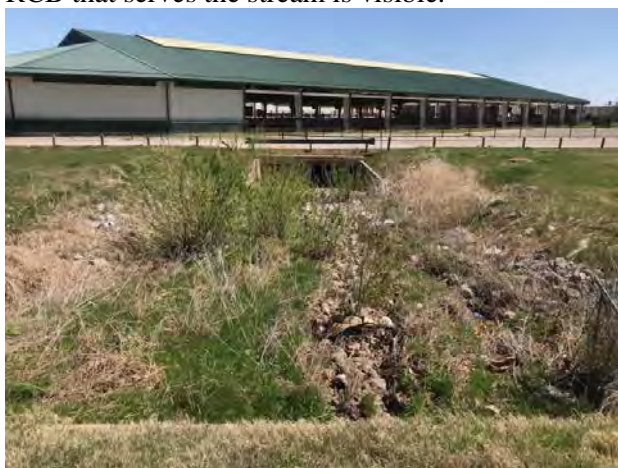
PS 7: Ephemeral stream, looking east from the east end of the RCB that carries the feature under I-44.

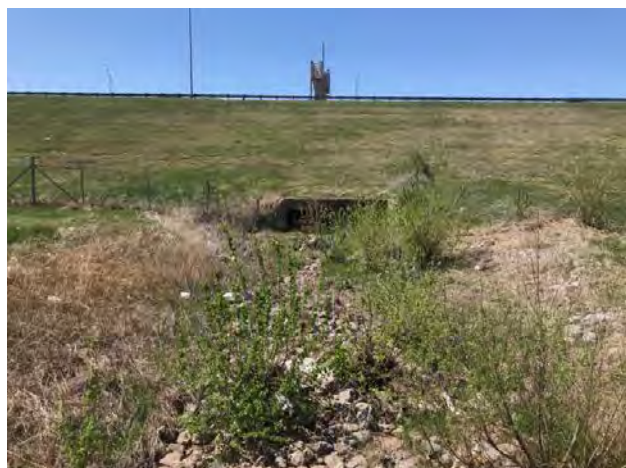
PS 8: Ephemeral stream, looking west from an RCB that carries the feature under a side road; the I-44 RCB is visible in the center of the image.

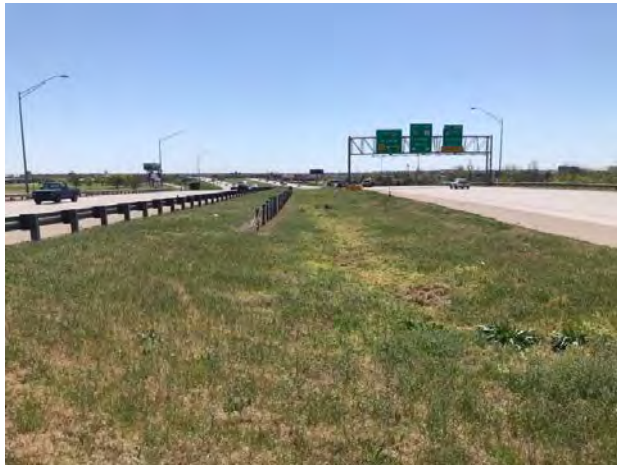
Photo Site 1 (PS 1): Existing R/W, looking south from the I-44 median at the top of the south slope wall.

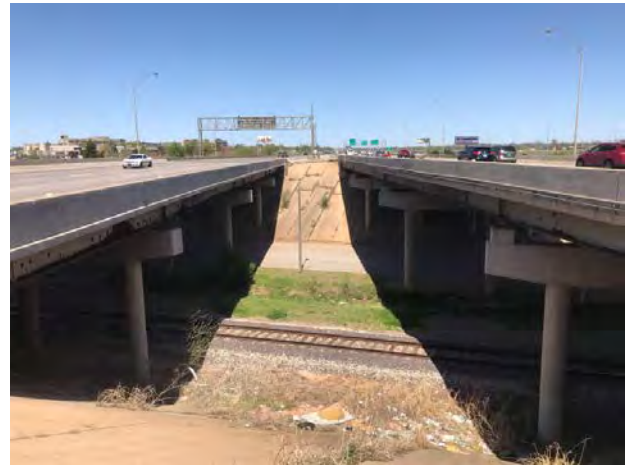
PS 1: Existing R/W, U.P. Railroad and Black Gold Drive, looking north from the I-44 median at the top of the south slope wall.

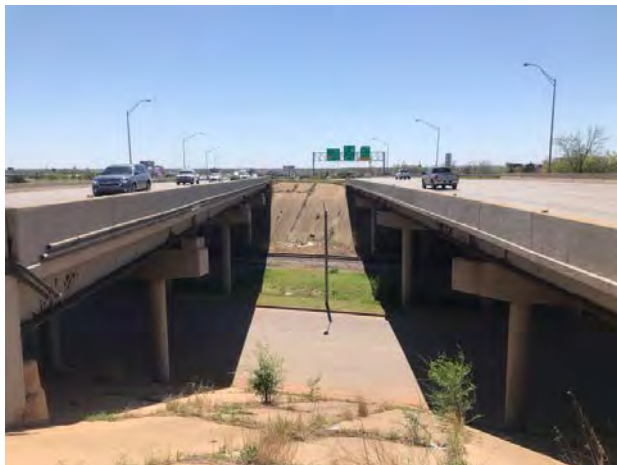
PS 2: Existing R/W, Black Gold Drive and U.P. Railroad, looking south from the I-44 median at the top of the north slope wall.

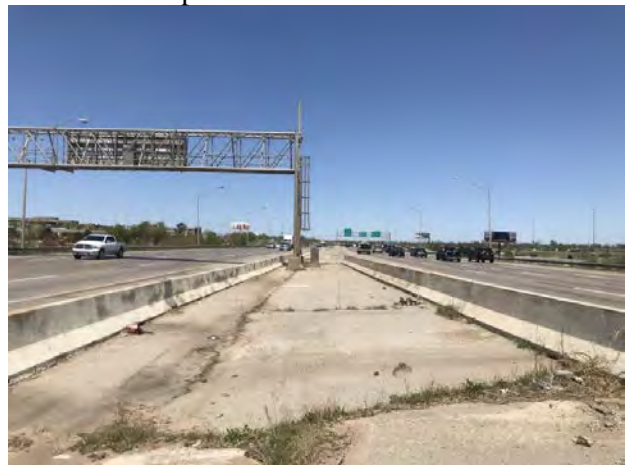
PS 2: Existing R/W, looking north from the I-44 median at the top of the north slope wall.

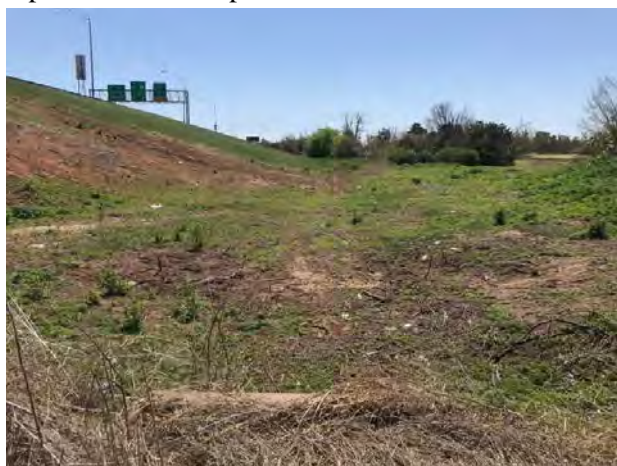
PS 3: Field Site 2 (FS 2, ephemeral drainage swale), looking south from the south side of the U.P. RR; the south end of a concrete pipe culvert is visible.

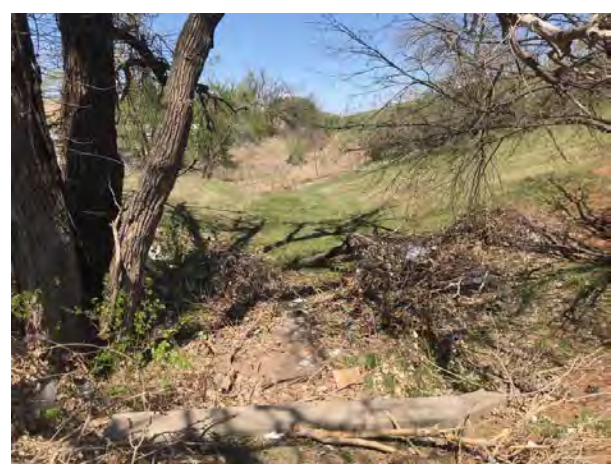
PS 4: FS 2, looking north from the north side of Black Gold Drive; the north end of a concrete pipe is visible, and FS 1 lies in the center background.

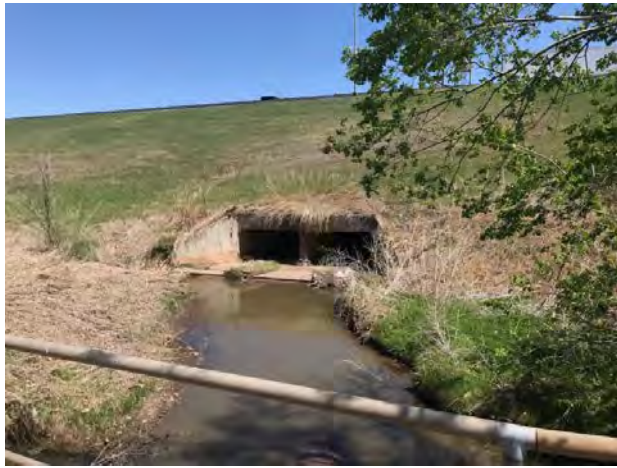
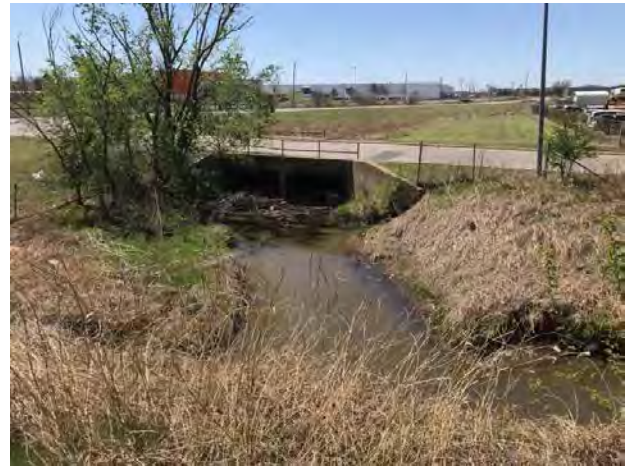
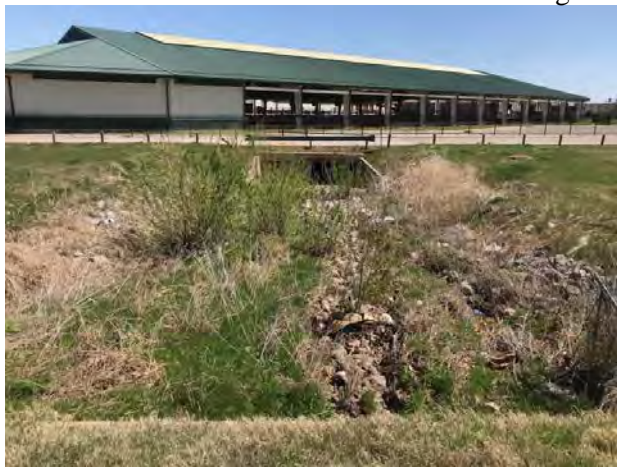
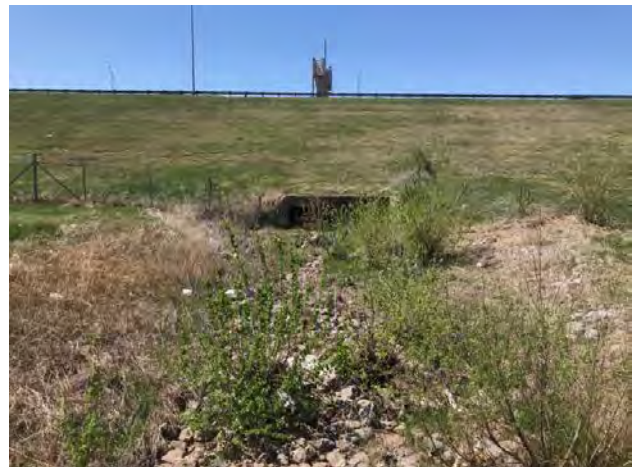
PS 5: FS 1 (ephemeral stream), looking NE from an RCB that carries the feature under a side road; the I-44 RCB is visible in the center of the image.

PS 6: FS 1, looking SW from the west end of the RCB that carries the feature under I-44; the confluence with FS 1 is visible at the lower left.

PS 7: FS 1, looking east from the east end of the RCB that carries the feature under I-44.

PS 8: FS 1, looking west from an RCB that carries the feature under a side road; the I-44 RCB is visible in the center of the image.
