# I-40 CLINTON

## Mobility and Freight Improvement Project

Inspection Reports

# Oklahoma Dept. of Transportation - Bridge Inspection Report

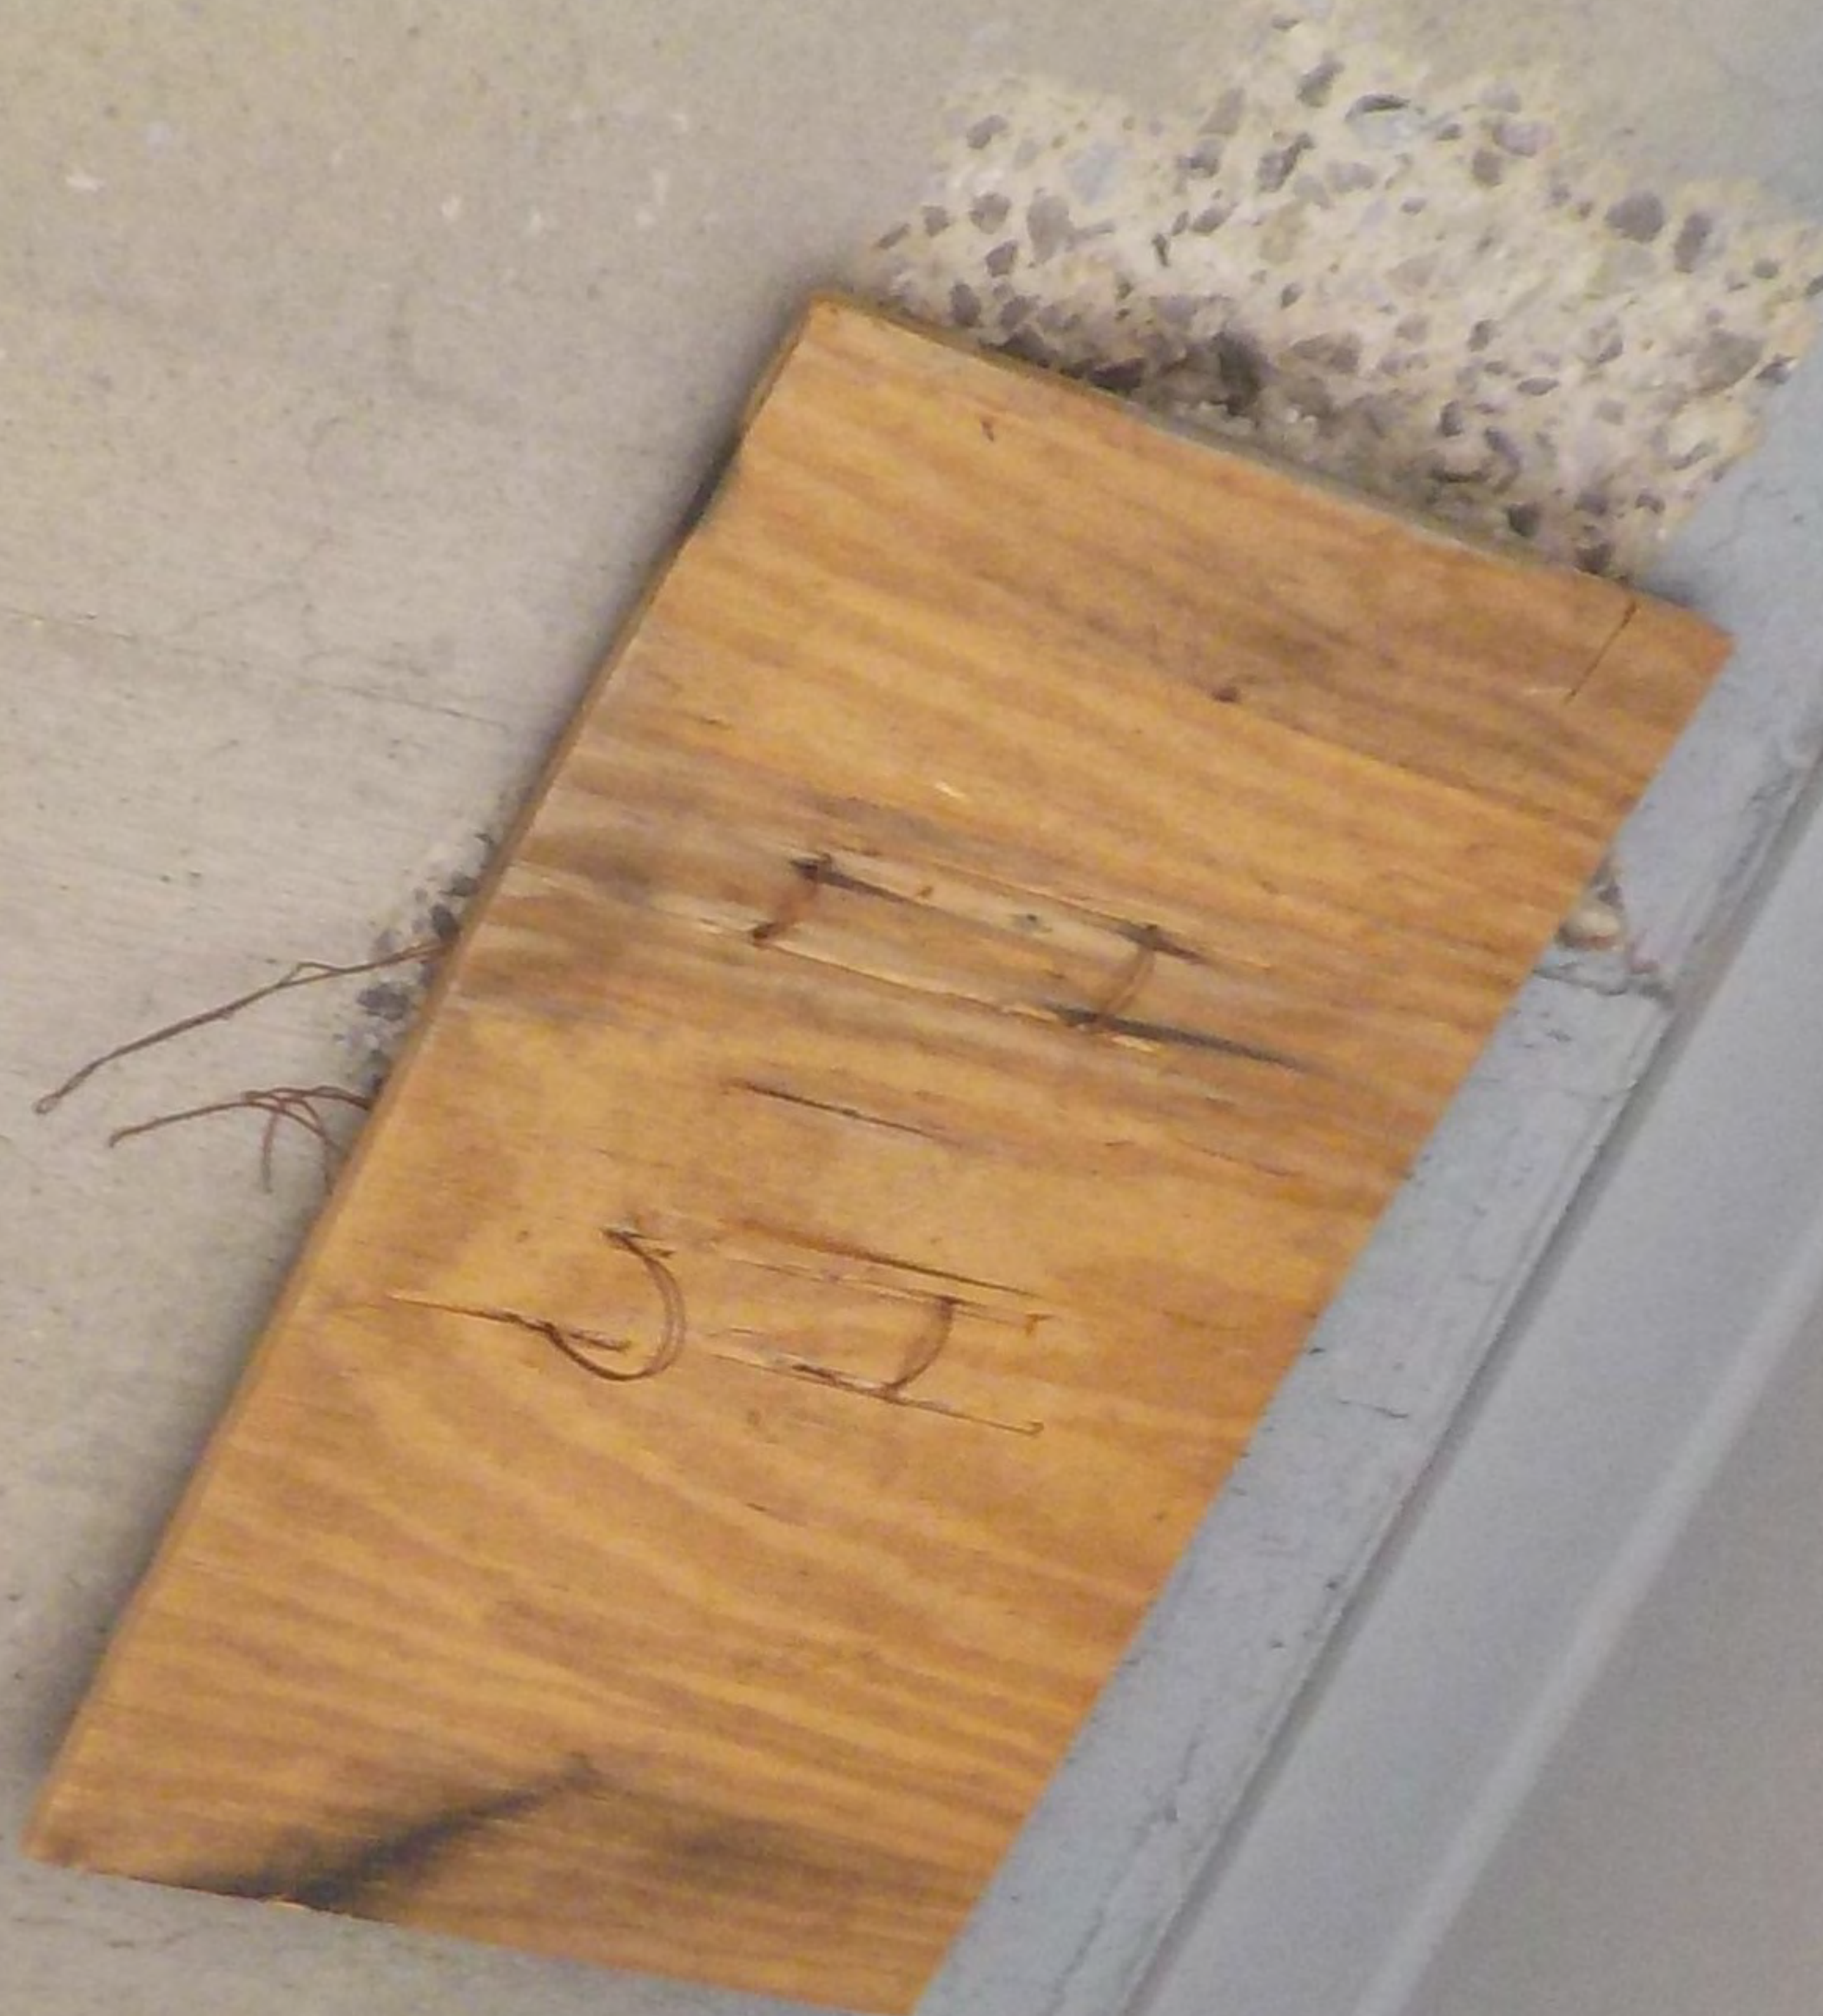
NBI - 17581  
STR # 20 02 1000 SX  
CUSTER CO.  
GNBC RR & NEPTUNE DR  
I-40 EB  
03-08-2023

25FT. 0 IN.
